# **ELKHORN SLOUGH**

## **A Review of the Geology, Geomorphology, Hydrodynamics and Inlet Stability**

Sea Engineering Incorporated  
Ken Israel and Steve Watt

5/31/2006

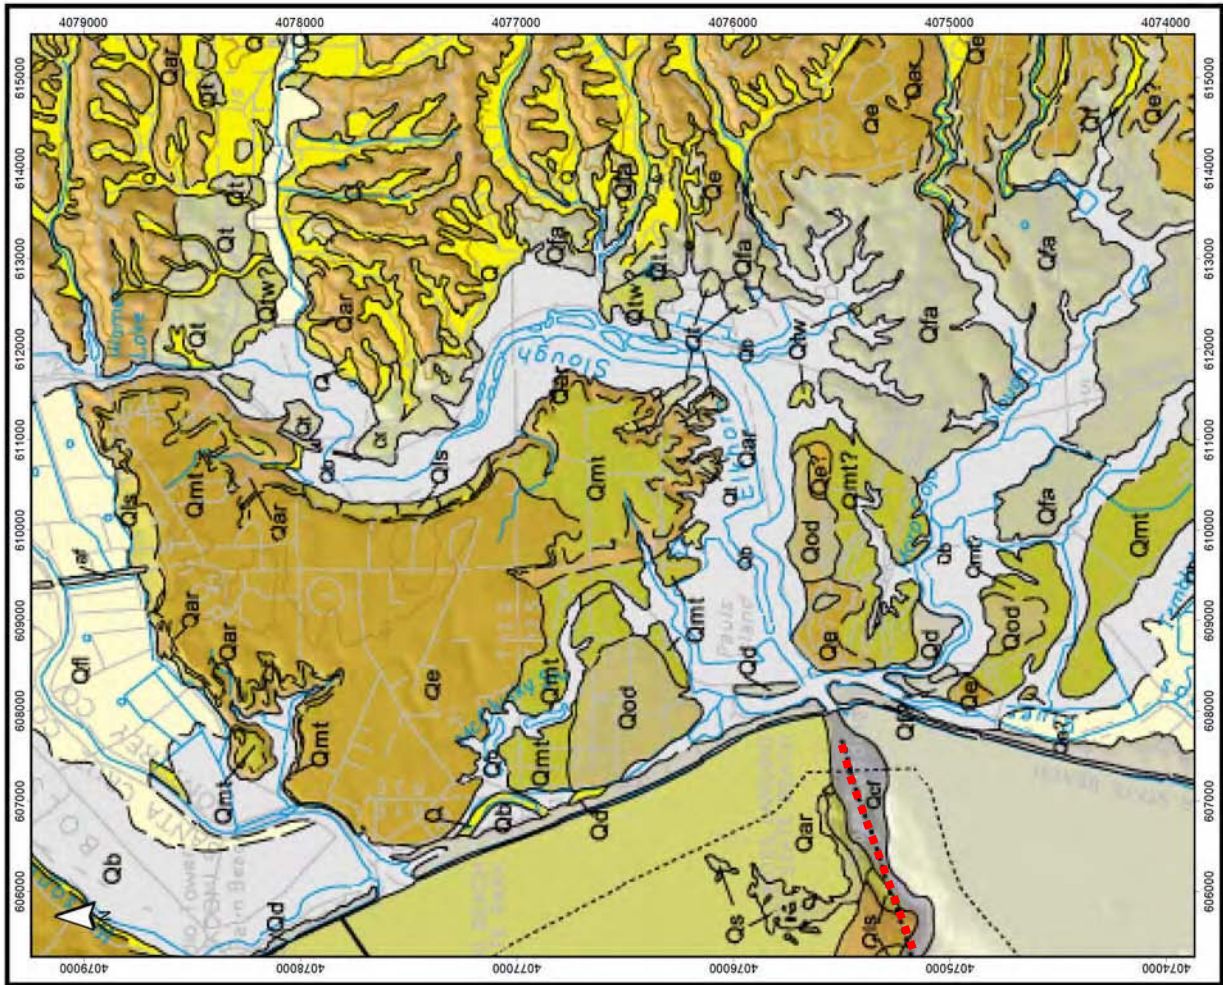
Map ID	Geologic description
Q	Alluvium
Qcf	Offshore canyon fill
Qe	Eolian sands
Qfl	Flood plain deposits
Qb	Basin deposits
Qd	Dune sand
Qls	Landslide deposits
Qs	Sand
Qt	Terrace deposits
Qod	Older dune deposits
Qmt	Marine terrace deposits
Qf	Alluvial fan deposits
Qfa	Fan deposits
Qar	Undifferentiated Aromas Sands Formation
Qtw	Terrace deposits

Figure 2. The geology of the Elkhorn Slough region is shown in this modified version of Wagner et al.'s (2002) geologic map of the Monterey Bay. The dashed red line indicates an inferred fault offshore in the Monterey Canyon axis. No other faults or rock outcrops are mapped in the immediate area. In general, the region is composed of differing sedimentary deposits of marine and non-marine gravel, sand, silt and clay that may extend well over 300 meters below the surface.

A section of a regional geologic map of the Monterey Bay by Wagner et al. (2002) is displayed in Figure 2. A fault is inferred offshore to the west of Elkhorn Slough in the axis of Monterey Canyon but is not mapped onshore. The Zayante-Vergeles Fault and the San Andreas Fault are located directly east of Elkhorn Slough (not shown on map). Rock exposures of Salinian Block granite, Monterey Formation, or Purisima Formation which have been mapped elsewhere onshore and offshore in Monterey Bay, do not crop out in the vicinity of Elkhorn Slough. The surficial sediments in the region are composed of unconsolidated marine and non-marine gravel, sand, silt and clay deposits. Top soils bordering Elkhorn’s salt marshes consist of recently stabilized, coarse-grained sand dunes that are easily penetrated by and drained of water delivered by local storms (Huertos and Shennan, 2002). Storm run-off causes moderate soil erosion potential on slopes less than 15 degrees and high erosion potential on greater slopes. Permeable mixtures of clay, silt, sand, and organic matter found on the surrounding upland areas also have high potentials for erosion from run-off during storm events

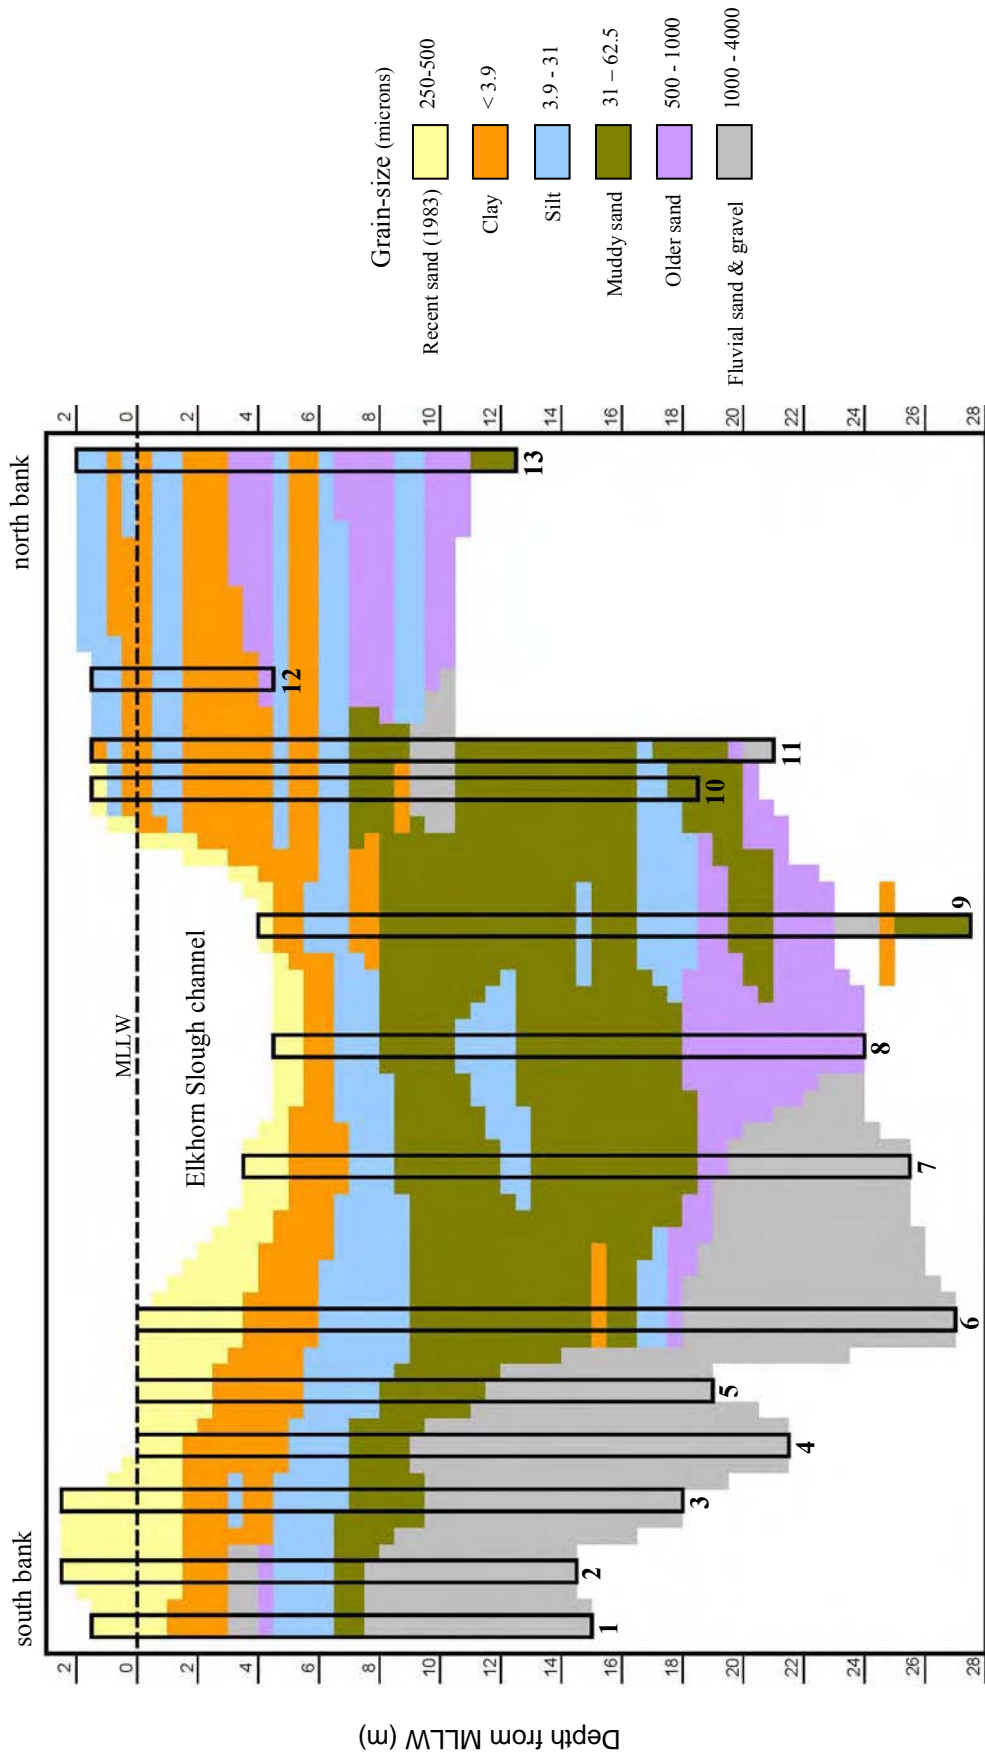
Figure 4. Simplified illustration of Schwartz (1983) descriptions of CALTRANS boreholes collected across HWY 1 Bridge. The cores are shown by depth corresponding to MLLW (dashed line) and color-coded in six different sedimentary layers. The sedimentary layers were inferred by Schwartz (1983) between the outlined and numbered sedimentary cores. The distinct fining upward sequence is illustrated in the bottom five layers with a sixth sand layer at the top, indicating the return to higher-energy conditions after the construction of the Moss Landing Harbor.

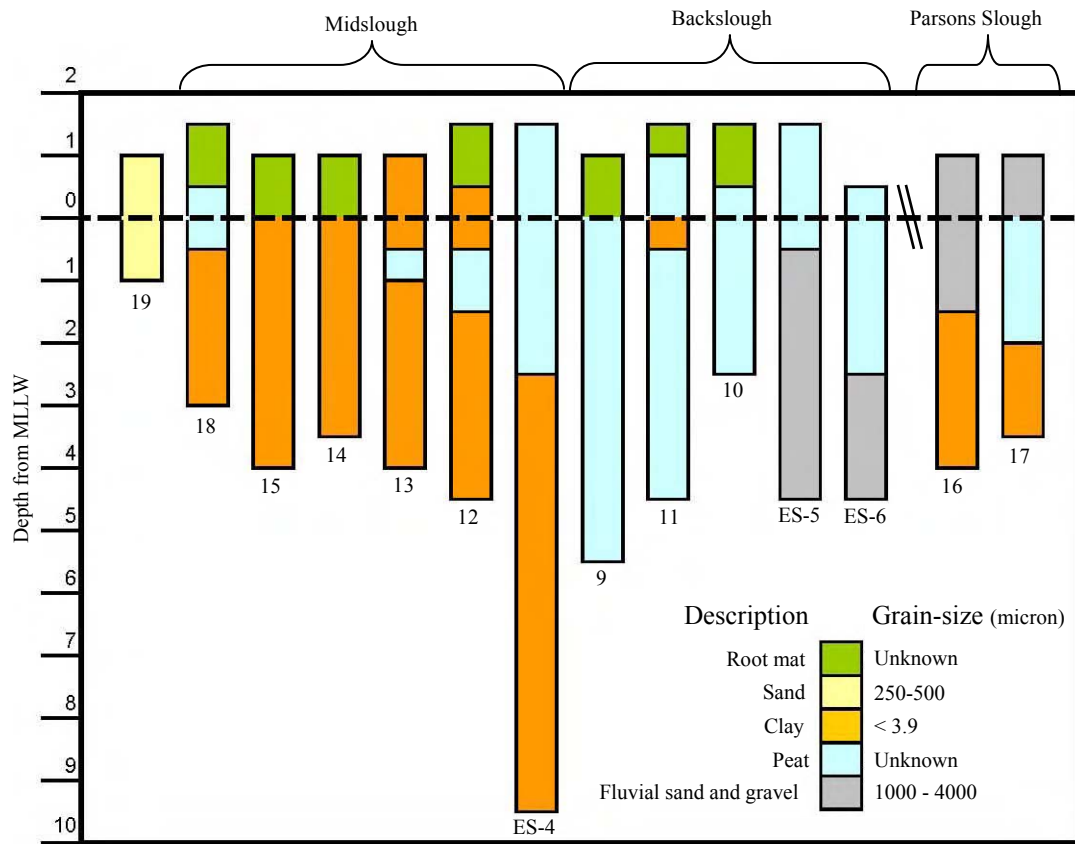
Figure 5. Sediment cores collected by Schwartz (1983) and Hornberger (1991) are ordered from left to right from Seal Bend to Elkhorn's Backslough. Parsons Slough cores are shown on the far right. Descriptions of the cores include a range of possible grain-size diameters in microns. Elevations from the DEM in Figure 3 were applied to the surface of the cores to orient the data in relation to Mean Lower Low Water (MLLW).

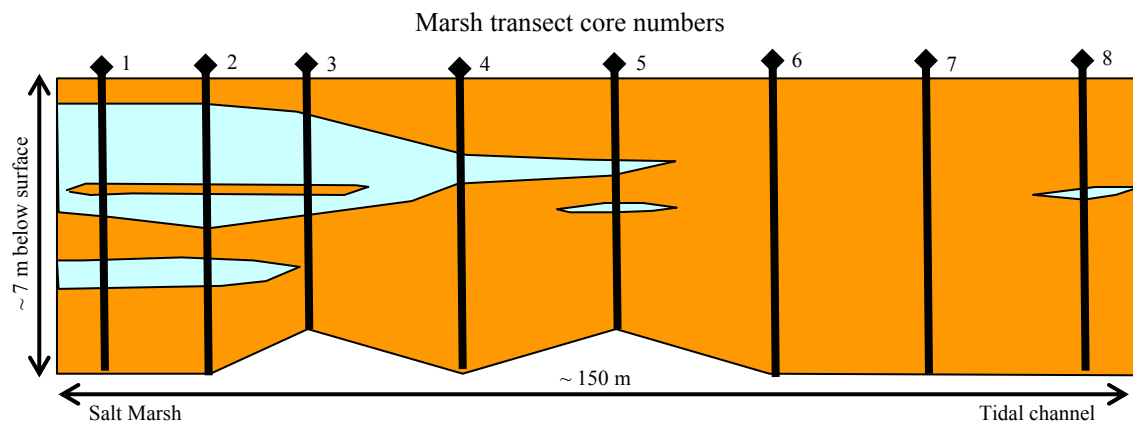
Figure 6. Descriptions of hand-driven cores modified after Schwartz (1983) along a transect between the salt marsh and tidal channel in Elkhorn's Backslough. Clay content is higher in cores closer to the tidal channel (orange), while peat concentration (light blue) is higher in cores closer to the salt marshes (see Figure 3 for core locations).

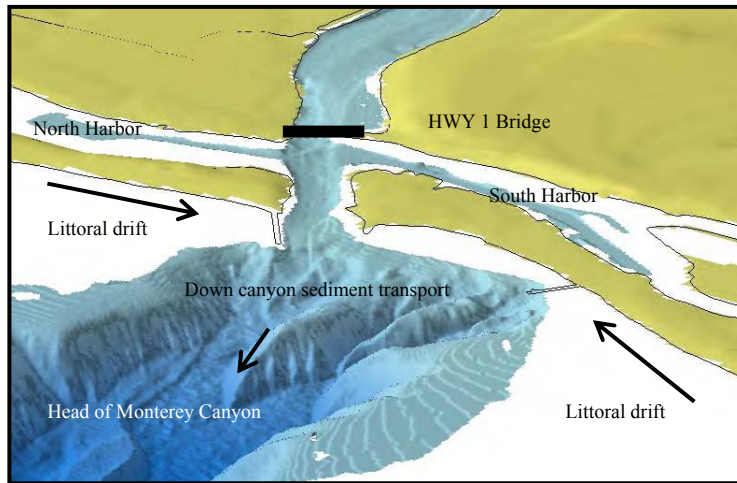
Figure 10. This image is a composite of bathymetry collected by the CSUMB SFML (blue) and a 10-meter USGS DEM (tan) looking over the head of Monterey Canyon and eastward towards Moss Landing Harbor and Elkhorn Slough. Sediment traveling in littoral drift is trapped in the head of Monterey Canyon and transported down the canyon axis. Some sediment from littoral drift enters the harbor where it deposits in the entrance channel.

The head of Monterey Canyon lies less than 100 meters offshore of the Moss Landing Harbor channel (Figure 10). The canyon head is an active, erosional feature. Slumping events at the canyon head have been observed in the recent past by researchers from Moss Landing Marine Laboratories (MLML), Monterey Bay Aquarium Research Institute (MBARI), United States Geological Survey (USGS), and California State University Monterey Bay (CSUMB); one event taking place during the Loma Prieta earthquake in 1989 (Greene, et al. 1991). If the canyon head continues to erode towards the harbor channel it could cause adverse impacts on both the harbor and Elkhorn Slough by significantly increasing the depth and width of the harbor, possibly increasing tidal currents, and tidal scour.

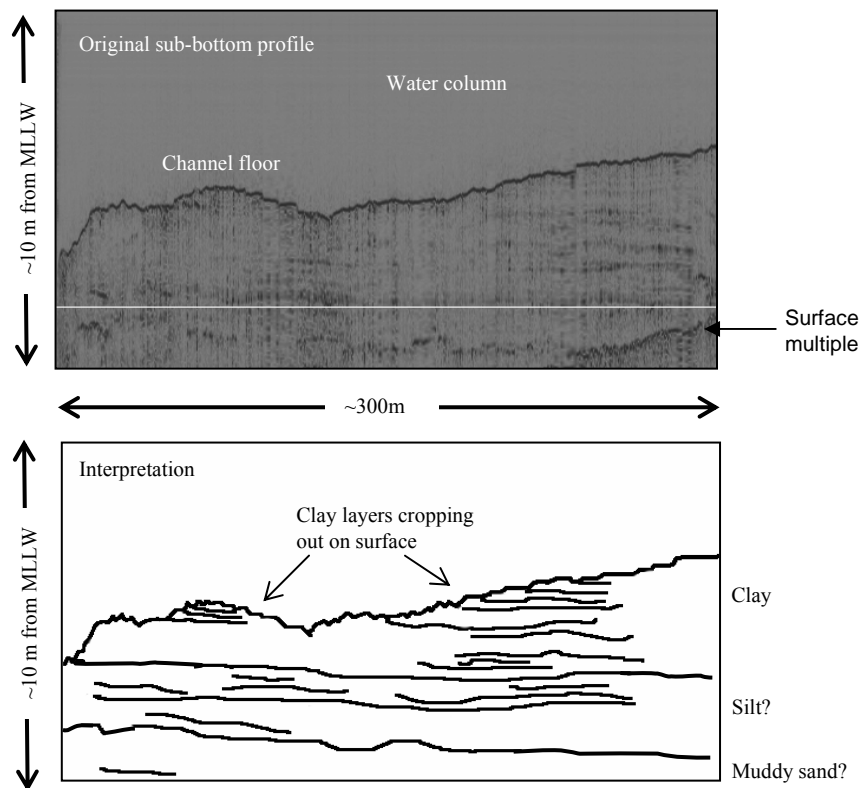
Figure 12. Three different sedimentary layers corresponding to the CALTRANS cores collected by Schwartz (1983) are interpreted in the sub-bottom record collected near the HWY 1 Bridge. The profile runs a few meters south of and parallel to the large tidal scour. Layers identified in the sub-bottom record have been eroded away in the adjacent tidal scour. The clay layers are thinly laminated and exposed on the tidal channel surface. The grainy appearance of the image may indicate the presence of organic detritus or coarse grained sediment mixed within the other layers.

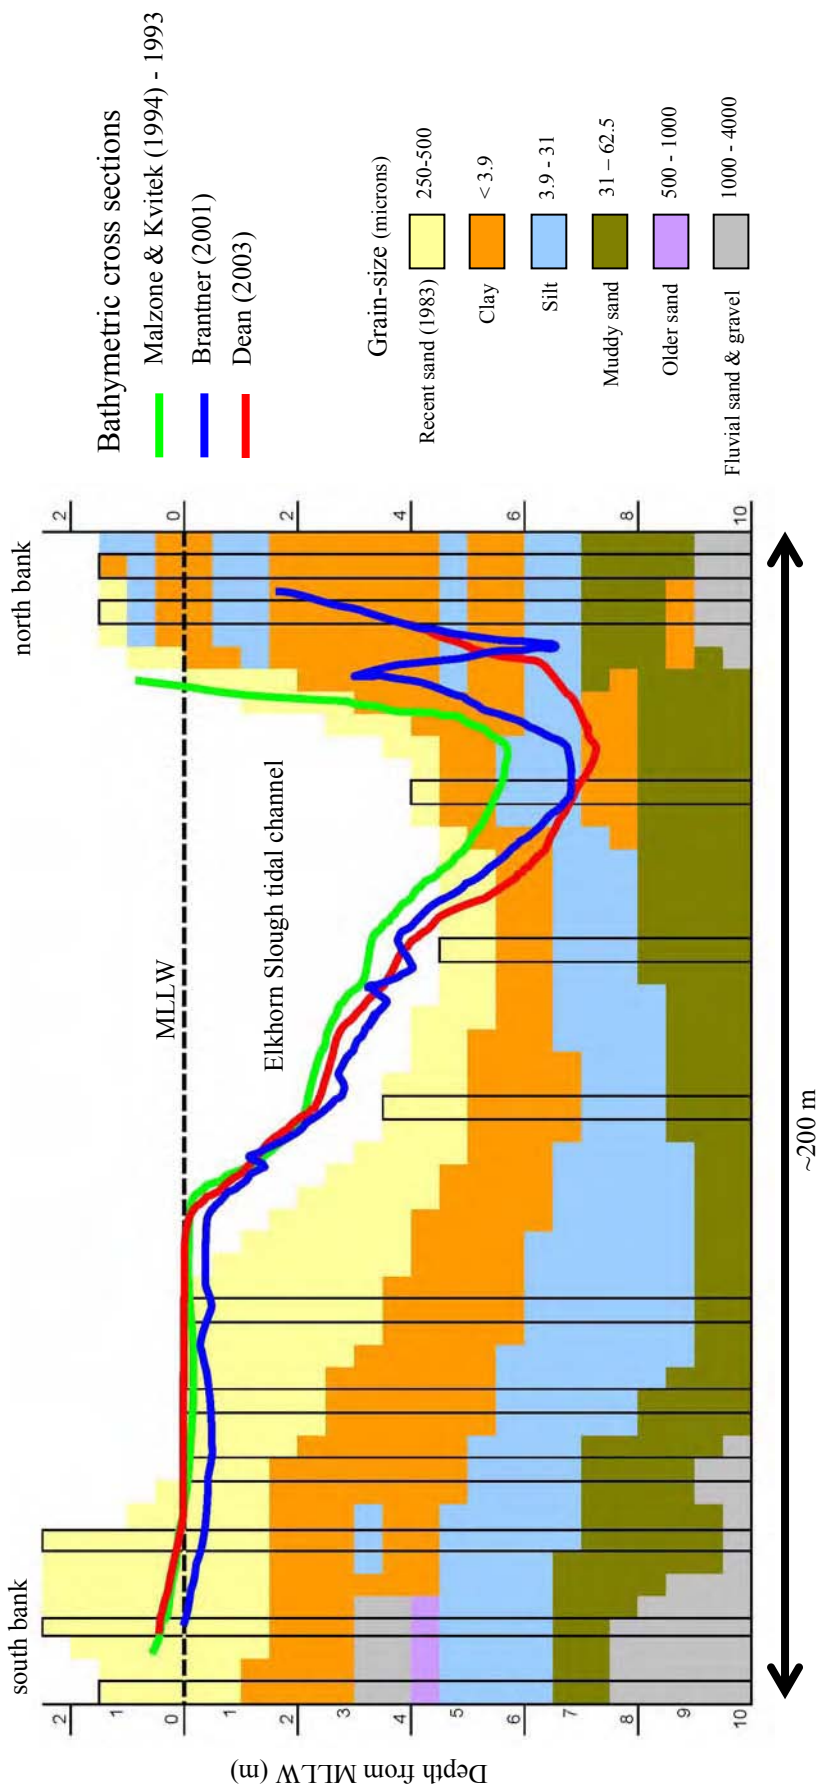
Figure 13. Bathymetric cross sections near the HWY 1 Bridge collected in 1993, 2001, and 2003 are shown superimposed over Schwartz's (1983) description of CALTRANS boreholes (see Figure 4). While this comparison is subject to a degree of positional error, the depth measurements from MLLW are probably accurate. The figure shows that the recent sand layer, clay layer and silt layer have been eroded away. This scour feature is almost 10 meters deep just ~250 m from the bridge, penetrating well into the muddy sand layer.

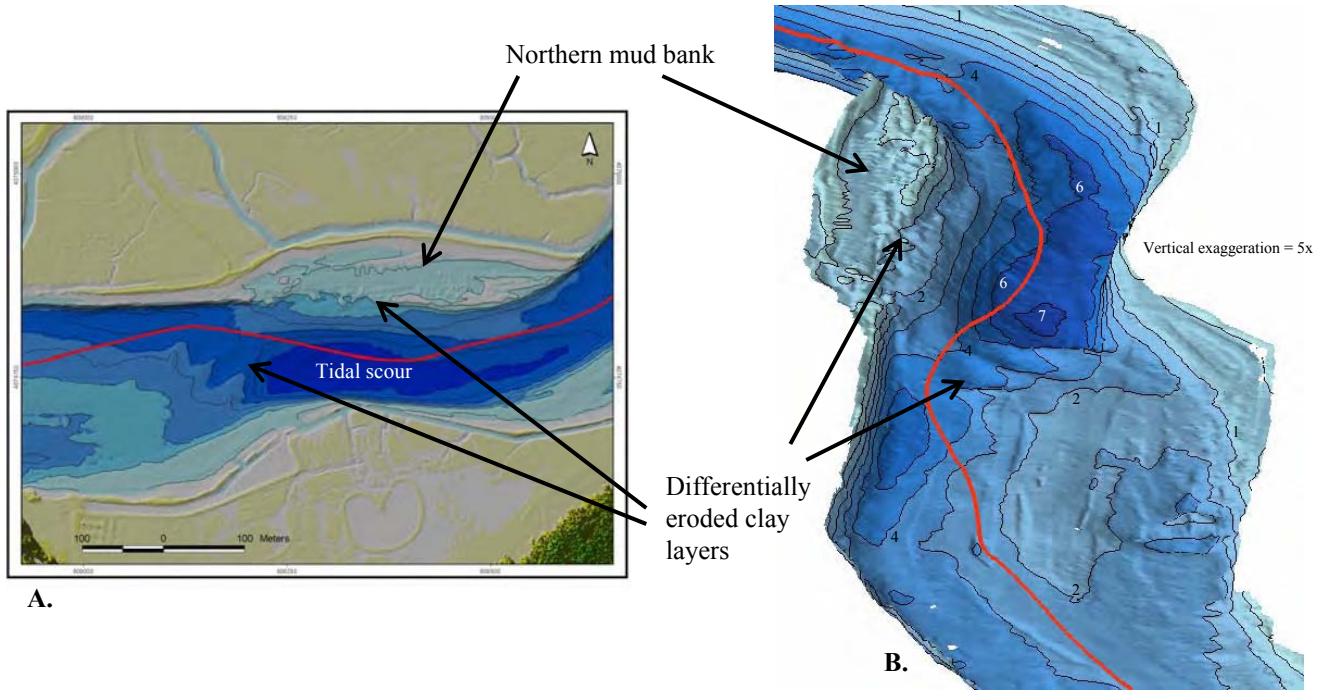
Figure 14. Two images are used to highlight a large tidal scour occurring near a constriction in the width of the Elkhorn Slough tidal channel. The point of view for Image B is down and eastward into the tidal scour (darkest blue). The thalweg crosses the channel from north to south at the constriction. A narrow, sub-tidal mud bank terrace lies opposite the scour and is being undercut and differentially eroded along exposed clay layers. The red line indicates the sub-bottom track line (below), which passes on the north side of the tidal scour. Bathymetry contours are at 1 m intervals.

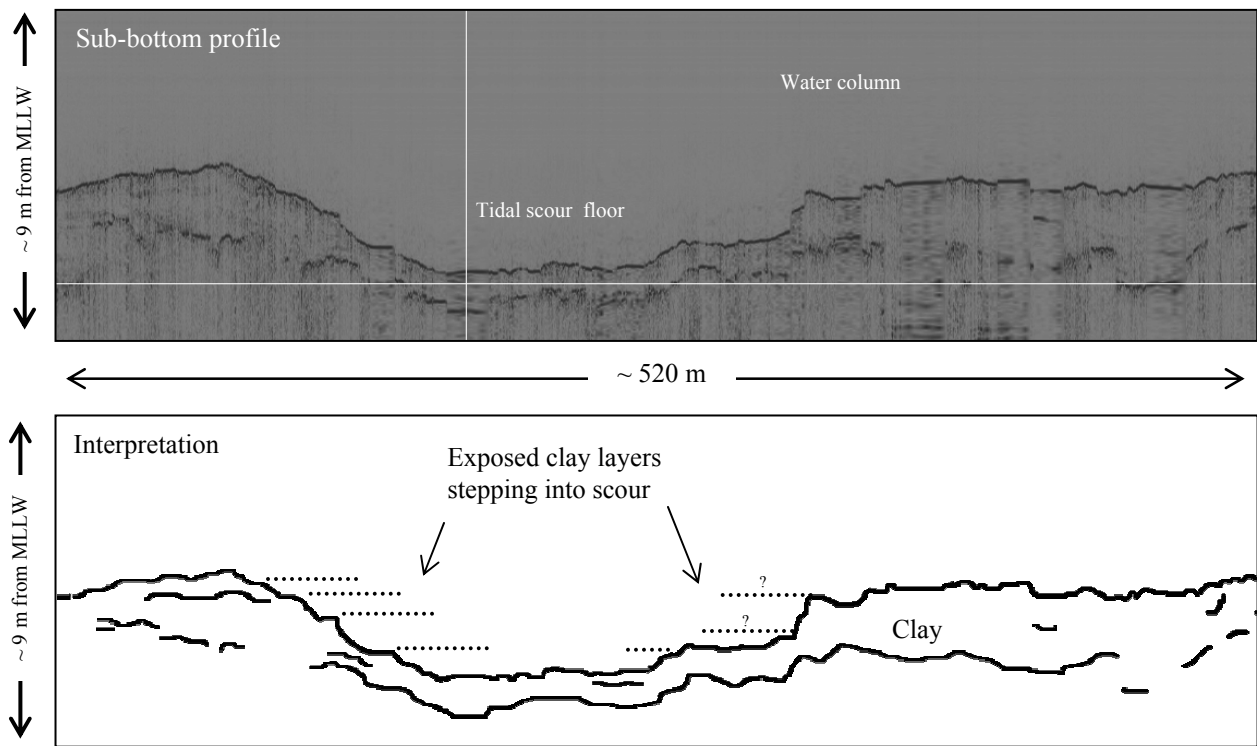
Figure 15. The sub-bottom profile runs along the northern side of the constriction tidal scour, glancing a series of clay layers stepping into the tidal scour (dashed lines). The blocky, uneven surface of the sub-bottom record indicates that clay layers are cropping out on the tidal channel surface, not just within the scour. The hard reflector between 7 and 8 meters below MLLW may be a semi-consolidated clay layer indicating a past tidal channel.

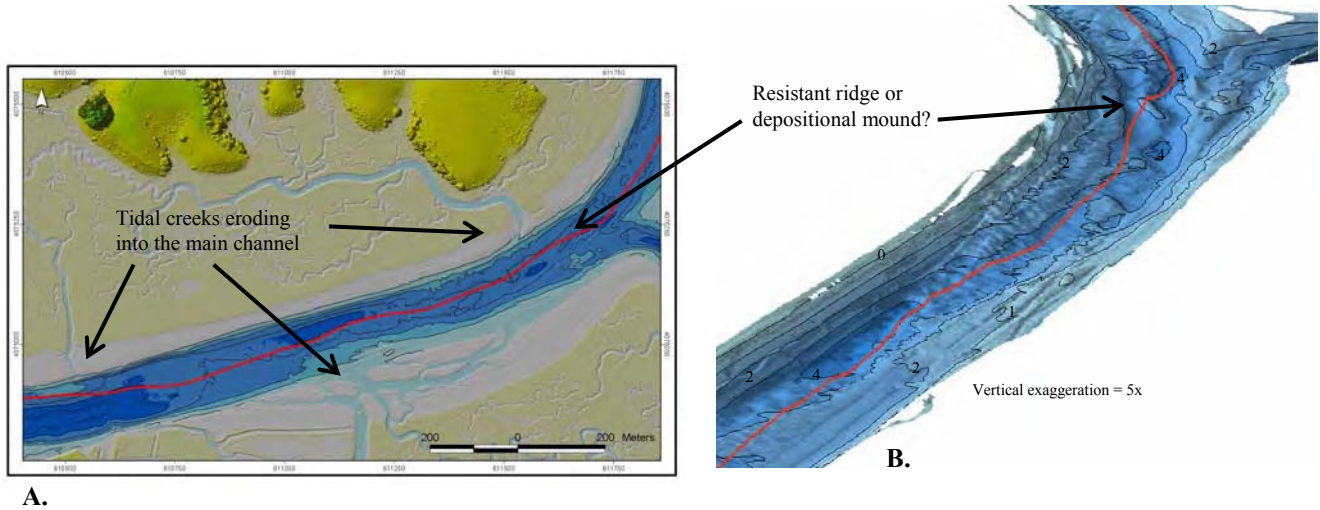
Figure 17. Many tidal creeks drain into and erode the banks of the main tidal channel between Seal Bend and Parsons Slough (Image A). Image B looks eastward up towards Parsons Slough from above. The bumpy channel floor gives the appearance of sediment waves, but the features are exposed consolidated clay layers (see below). The red line illustrates the path of the sub-bottom track line shown below. Bathymetry contours are at 1 m intervals.

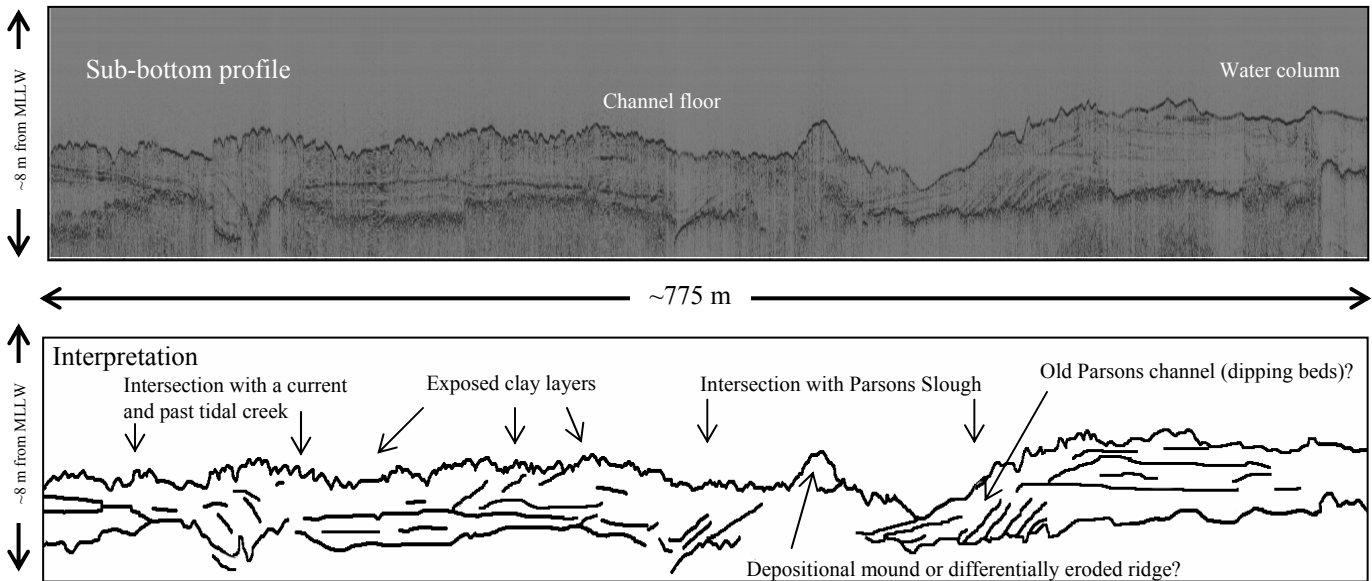
Figure 18. A variety of features are present in the sub-bottom record between Seal Bend and Parsons Slough. Sub-surface layers are disturbed at intersections with past and current tidal creeks and Parsons Slough. The hummocky, angular appearance of the channel floor indicates that clay layers are exposed on the surface with a possible exception near Parsons, where a coarse-grained mound may have been deposited. High current speeds measured in this location suggest that the feature is most likely a differentially eroded clay ridge.

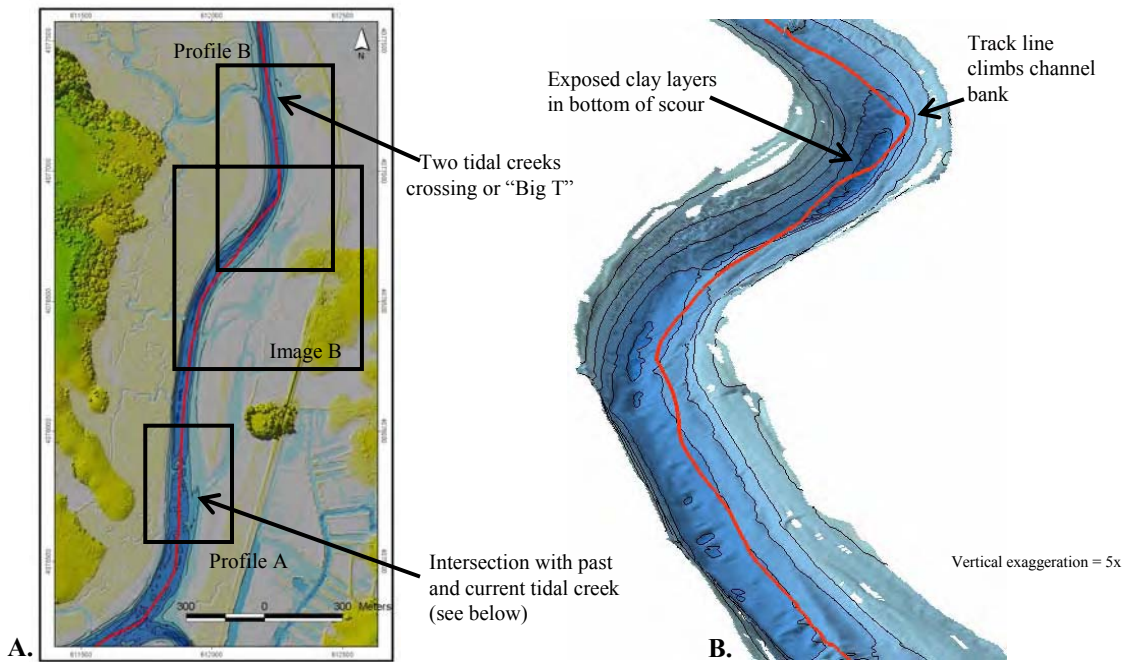
Figure 20. Image A is an overview of the stretch between Parsons Slough and where two tidal creeks perpendicularly intersect Elkhorn Slough in the same place, called the “Big T”. Image B is a perspective view looking northeastward across two tidal scours that occur in an s-turn prior to the “Big T”. The locations of the sonar records are indicated in Image A.

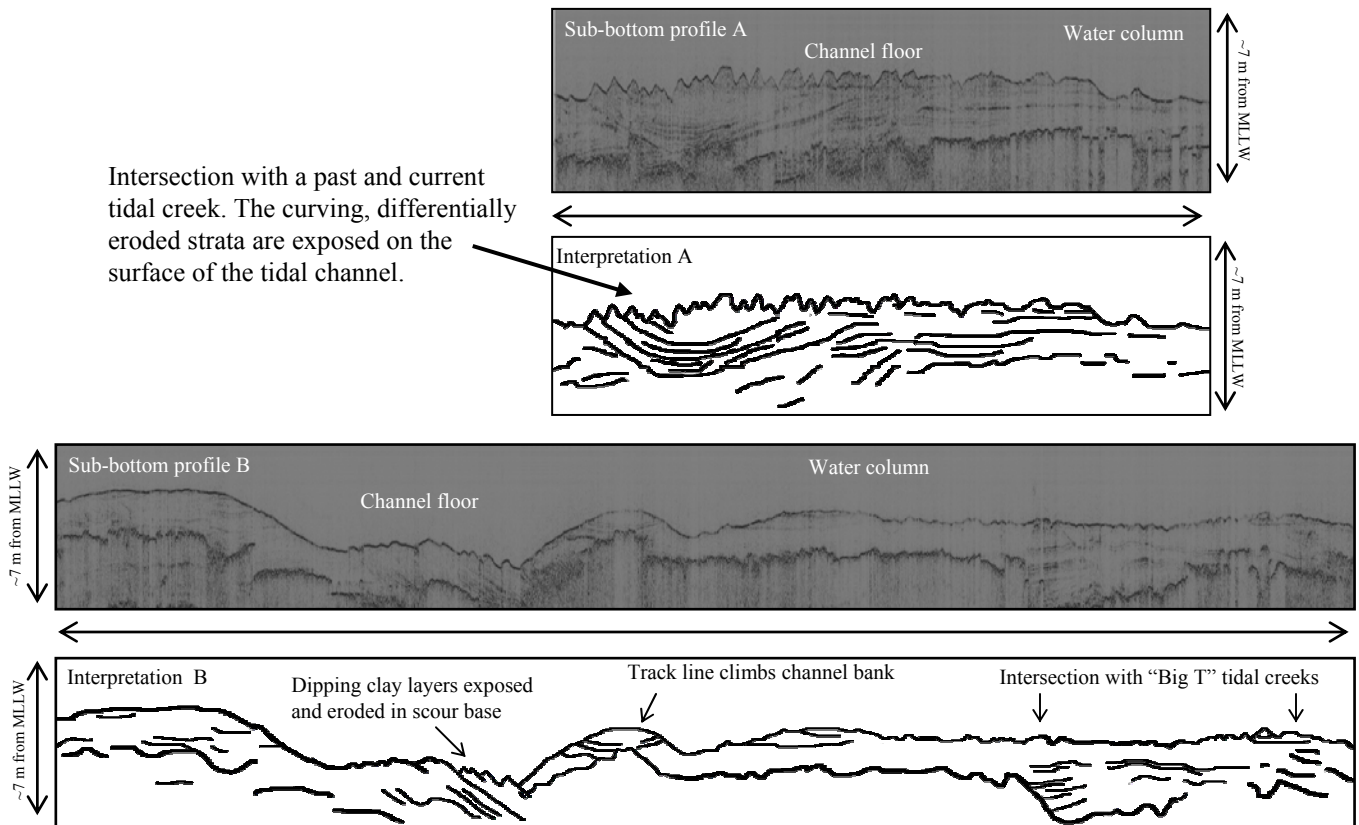
Figure 21. Two sub-bottom records are presented above. In sub-bottom record A, an old tidal creek intersects with the main tidal channel. Eroded clay layers from the tidal creek are exposed on the channel floor, creating the blocky angular appearance. In sub-bottom image B, angular clay layers are exposed in the base of a tidal scour and another old tidal creek is imaged in the same location as the current “Big T” tidal channels.

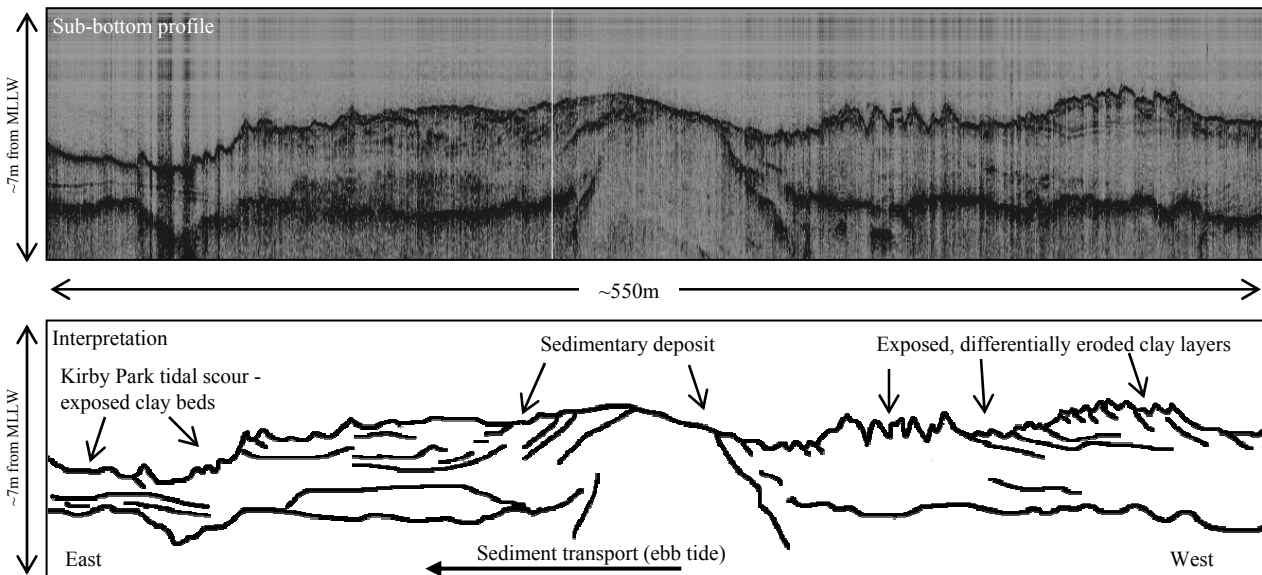
Figure 23. Exposed differentially eroded clay layers in the tidal scour near Kirby Park become gradually deposited over by sediments entering up channel from a tidal creek. The immediate return of the channel floor to exposed angular clay layers west of the deposit indicates that the sediments are being transported down channel towards Kirby Park on ebbing tides.

The sub-bottom track line runs through the tidal scour near Kirby Park, recording the angular blocky channel floor found at most other locations in the slough (Figure 23). The features are interpreted to be differentially eroded clay layers exposed on the seafloor. Following the scour, a unique feature is encountered, a sedimentary deposit. Approximately 200 meters west of Kirby Park, tidal channel depths decrease to 1.5 meter and the channel floor gradually becomes smoother where sediment has deposited over the clay layers. Clay laminations are not indicated at the peak of the deposit and the semi-consistent hard reflector interpreted to be an old tidal channel base in previous seismic reflection records has also washed out. The sediment was probably delivered by the large tidal creek to the west of the deposit and may be composed primarily of sand due to the hard surface reflection recorded in the seismic reflection image. Immediately west of the deposit, the seafloor abruptly returns to the usual angular, blocky appearance indicating clay layers exposed on the channel floor. The gradual build up of sediment of the eastern side of the deposit, followed by the gradual return to exposed clay layers indicates that the sediment is probably being transported down channel towards Kirby Park, not upstream towards Hudson’s Landing. This indicates that currents in this section are probably stronger on the ebb tide than the flood tide.

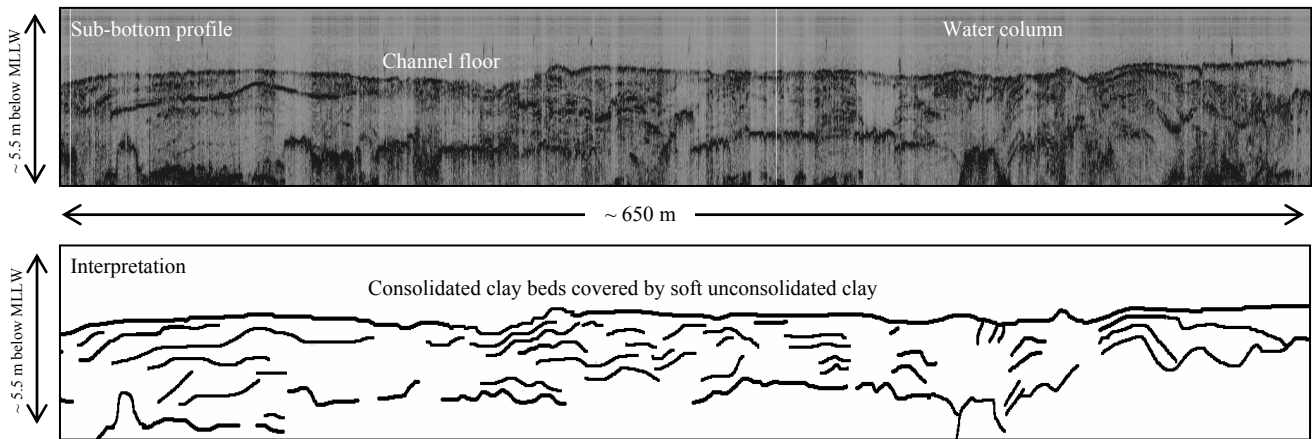
Figure 25. The sub-bottom record after the two tidal scours illustrates the decreased magnitude of the erosional gradient upslough. The channel floor is smooth indicating that near surface clay beds are undisturbed and covered by up to 1.5 m of soft unconsolidated clay. While the sub-bottom images do not indicate that erosion is taking place, observational evidence indicates that the soft clay deposit is eroding in many places in the upper reaches of the Slough.

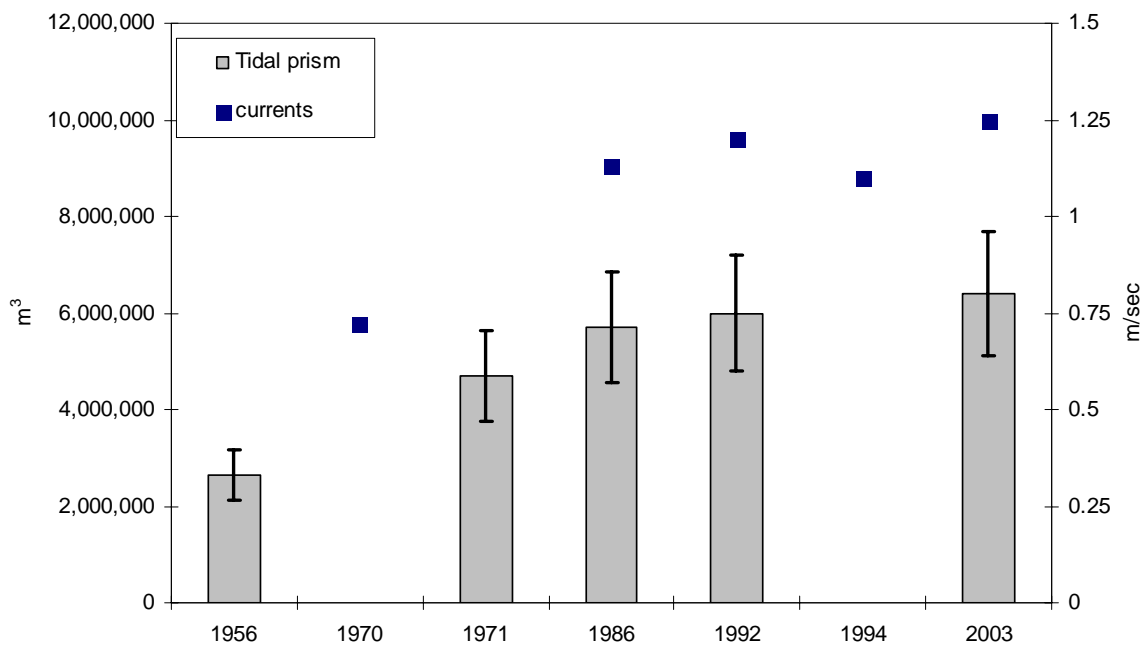
Figure 27. Comparison of increasing tidal prism (gray bars) and increasing ebb tidal currents measured at the HWY 1 Bridge (blue squares) over time in Elkhorn Slough.

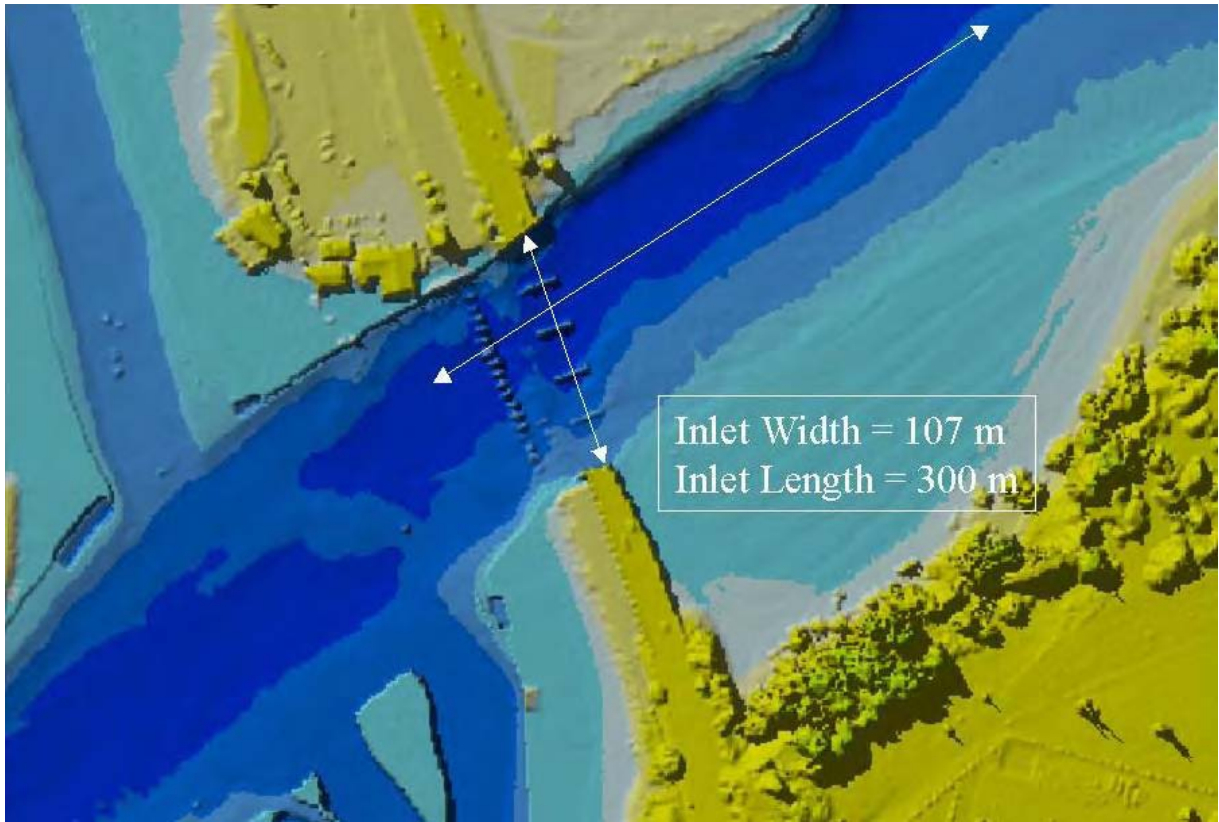
Figure 28. Dimensions of Elkhorn Slough Inlet used for inlet equilibrium stability analysis.

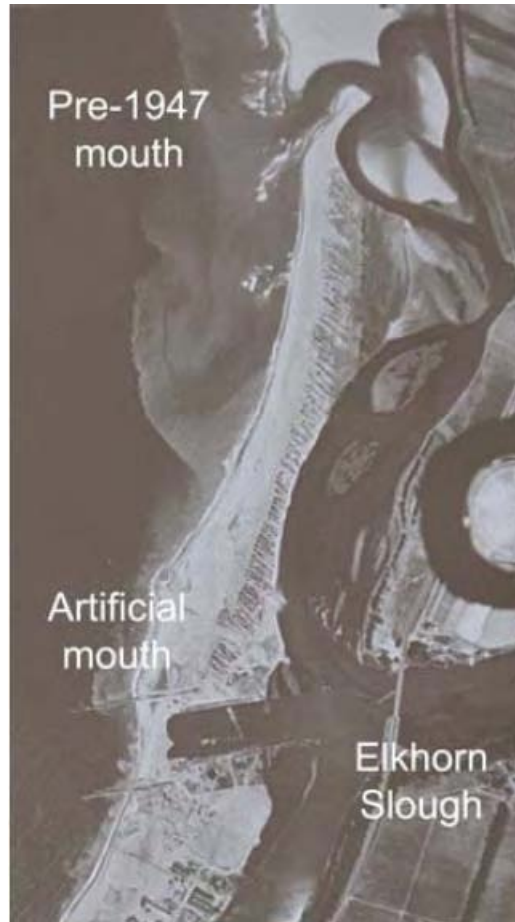
Figure 29. Image of Moss Landing Harbor Inlet and Elkhorn Slough Inlet prior to opening permanent inlet by the USACE in 1947 (Courtesy of ESNERR).

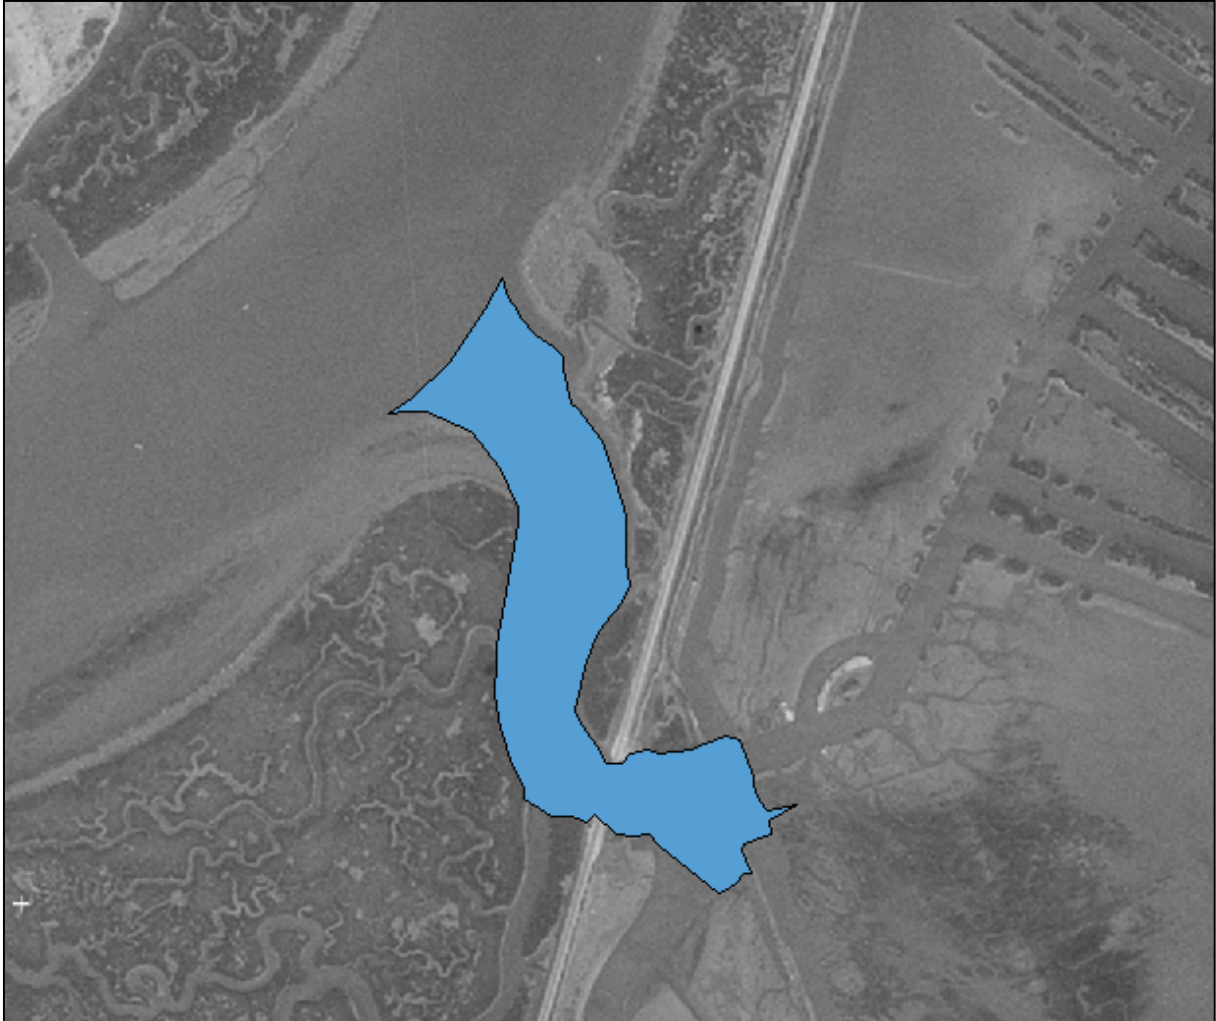
Figure 30. Parsons Slough Inlet extends from under the Union Pacific Railroad trestle to main channel of Elkhorn Slough.

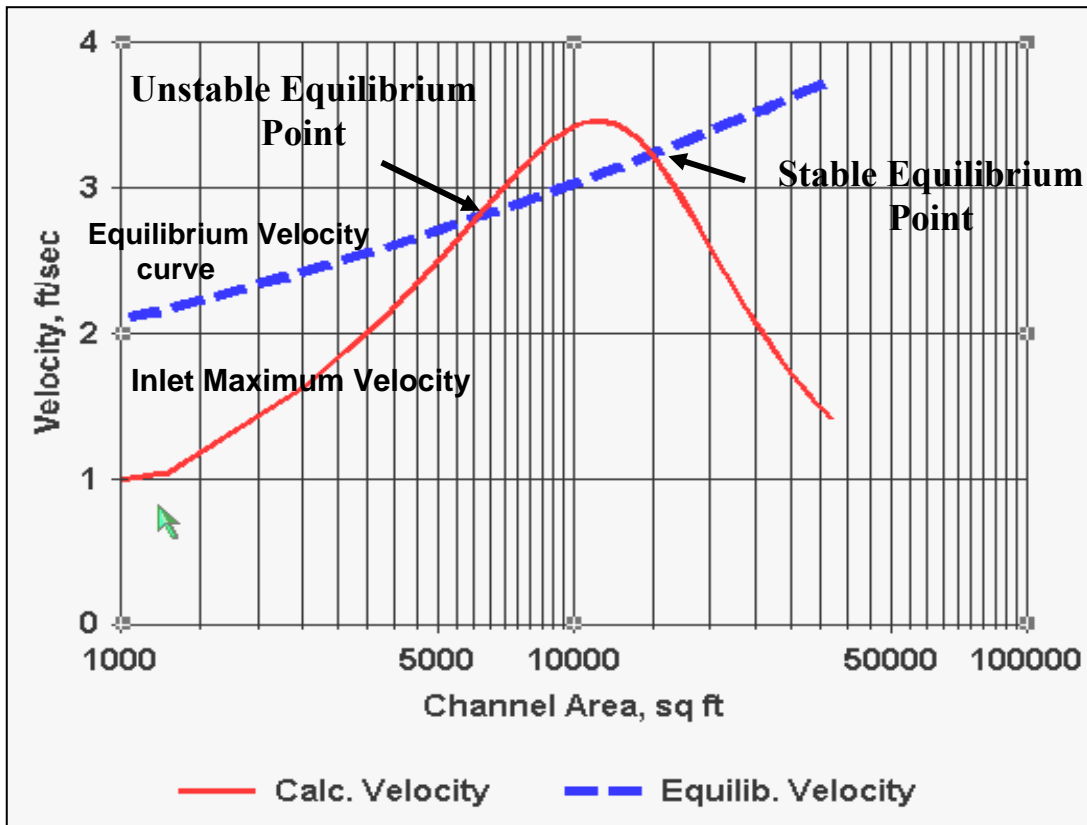
Figure 31. Example of an Escoffier Plot for Inlet Stability

The curves in Figure 31 intersect at two points, however these curves may also have only one point (a tangent), or there may be no intersection at all. According to Escoffier (1977) and O'Brien (1969), a right-side intersection of the curves, beyond the maximum current peak, is a stable inlet area point. If there is an increase in inlet area this will cause a movement along the stability curve back to its starting equilibrium point. For instance, if channel area increases (moves right on the curve from the stable equilibrium point), velocity will fall and more sediment can fill in the channel to bring it back to equilibrium (Seabergh, 1997). If the inlet area decreases through deposition beyond the equilibrium point then velocity will increase beyond equilibrium level, which will scour the inlet increasing the inlet area to the equilibrium point. If there is an intersection on the left side then the inlet is unstable, where

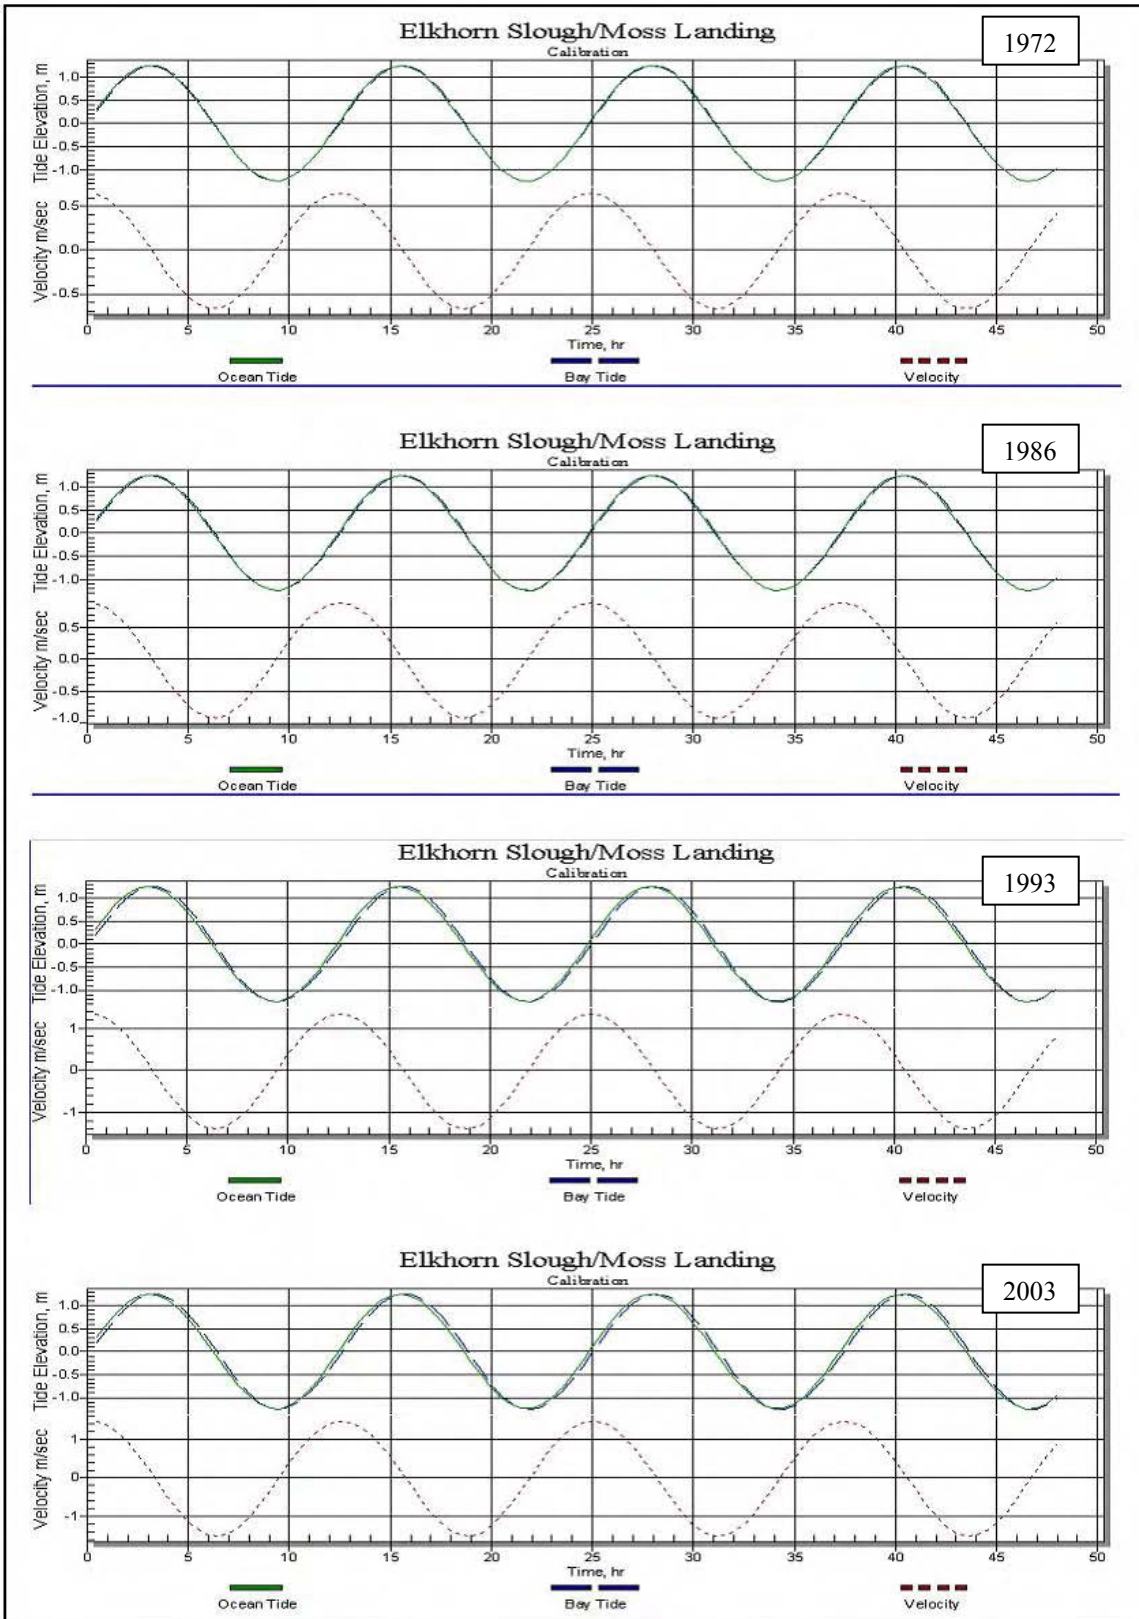
Figure 32. Calibration of Elkhorn Slough Inlet hydrodynamics – 1972-2003
