# **ELKHORN SLOUGH**

## **A Review of the Geology, Geomorphology, Hydrodynamics and Inlet Stability**

Sea Engineering Incorporated  
Ken Israel and Steve Watt

5/31/2006

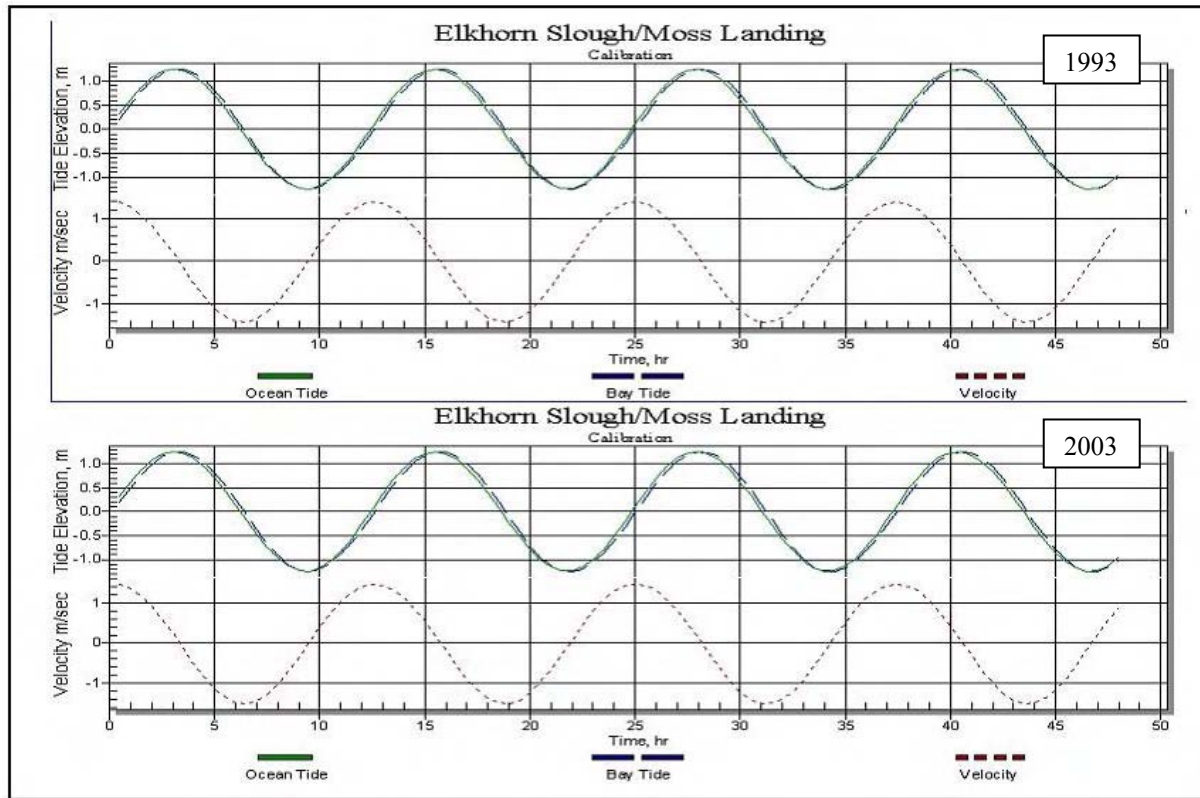
Figure 33. Calibration of Parsons Slough Inlet hydrodynamics – 1993-2003

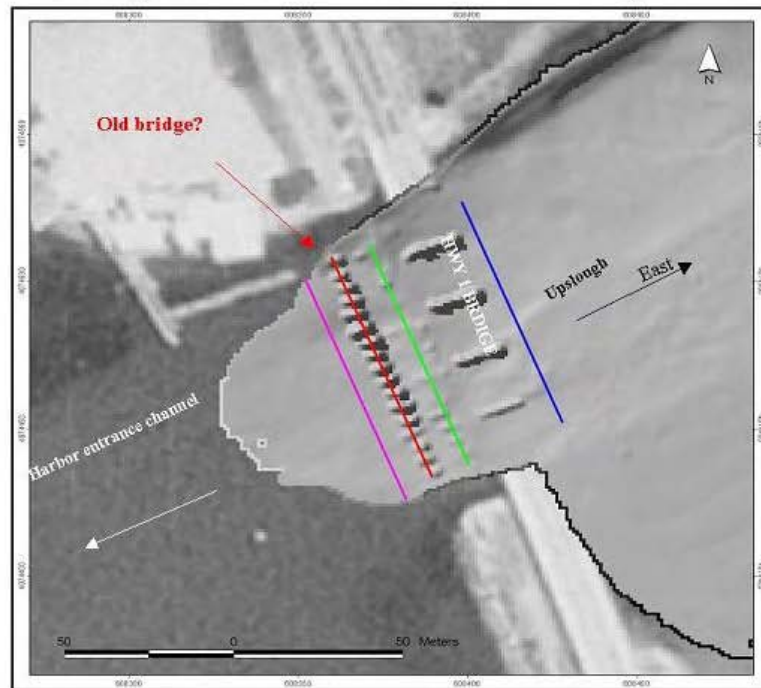
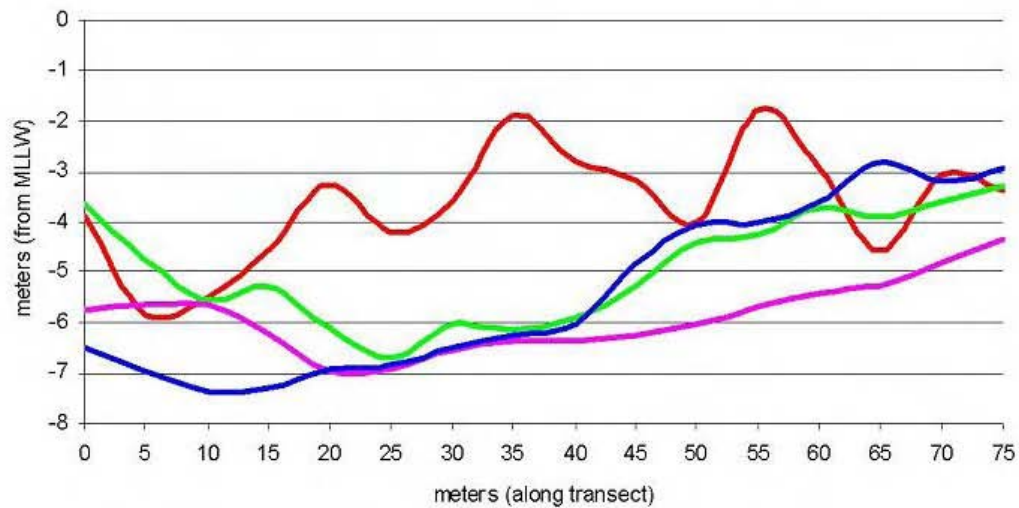
Bathymetric cross-sections near HWY1 Bridge

East of bridge (blue) Cross Sectional Area = approx 450 m<sup>2</sup>

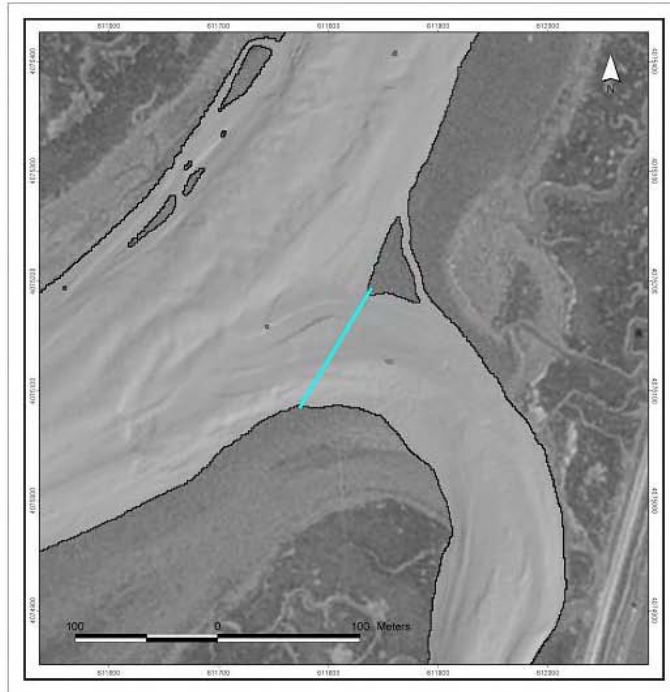
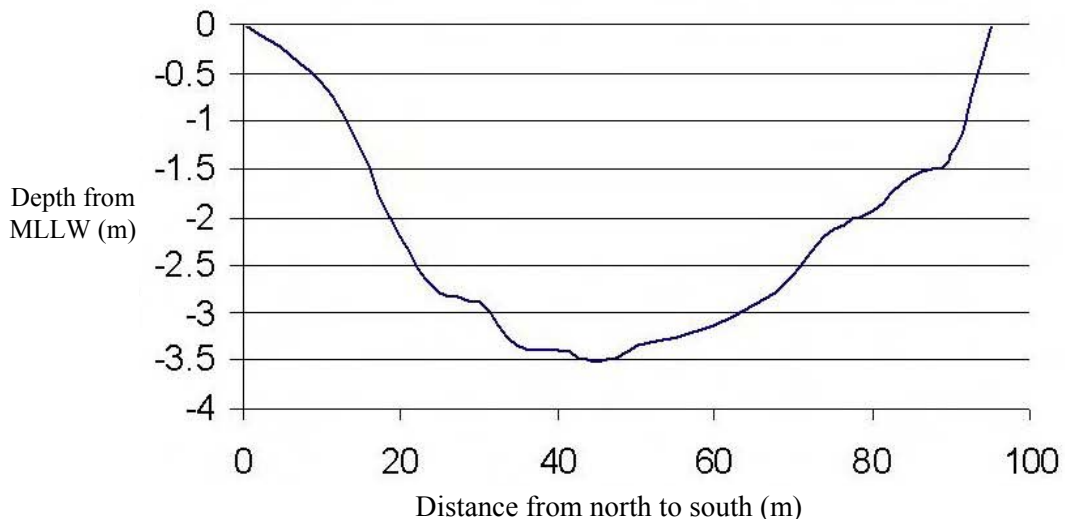
Parsons Slough mouth profile

Figure 35. Representative bathymetric cross sections used in the calculation of inlet cross sectional area for the mouth of Parsons Slough.

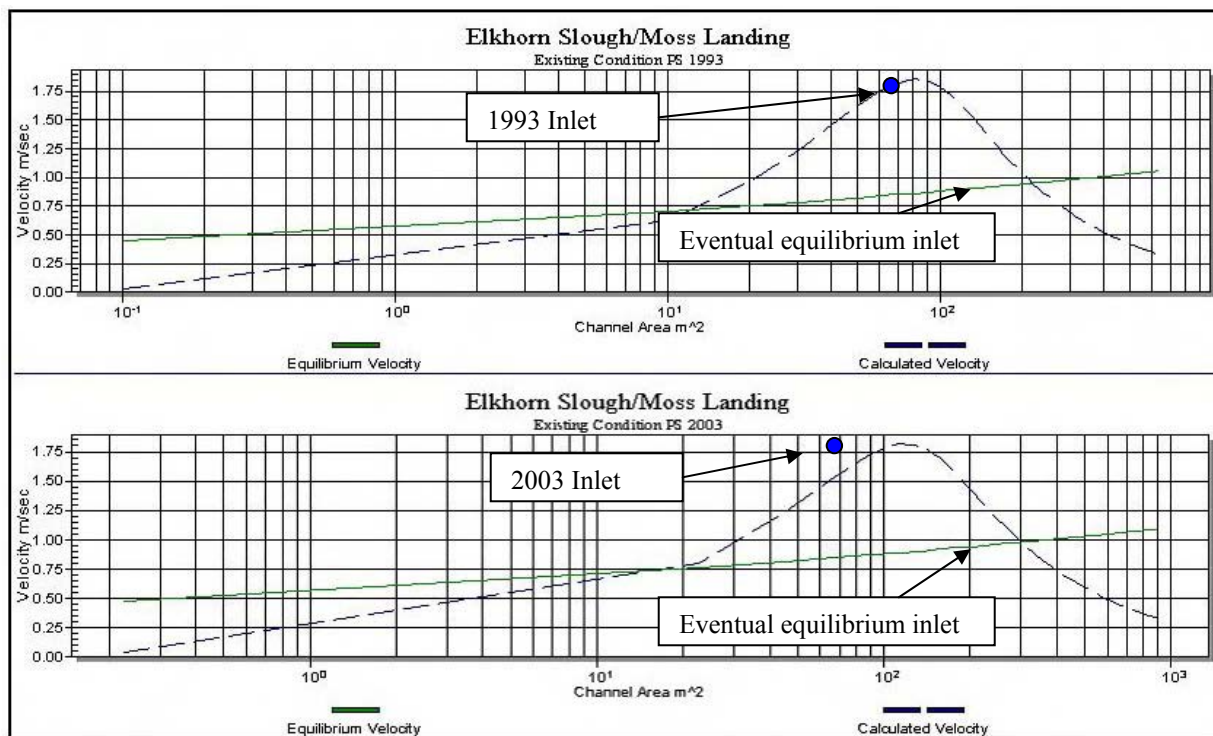
Figure 37. Escoffier plot showing Parsons Slough Inlet location with respect to channel area and eventual equilibrium area – 1993-2003.

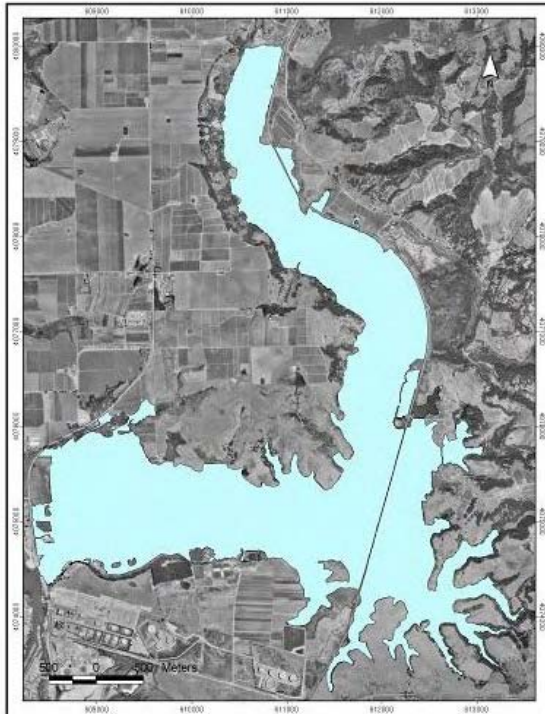
1. Modified wetlands area from ESNERR GIS (from HWY 1 Bridge, not including North Marsh or Bloom/Porter Marsh)

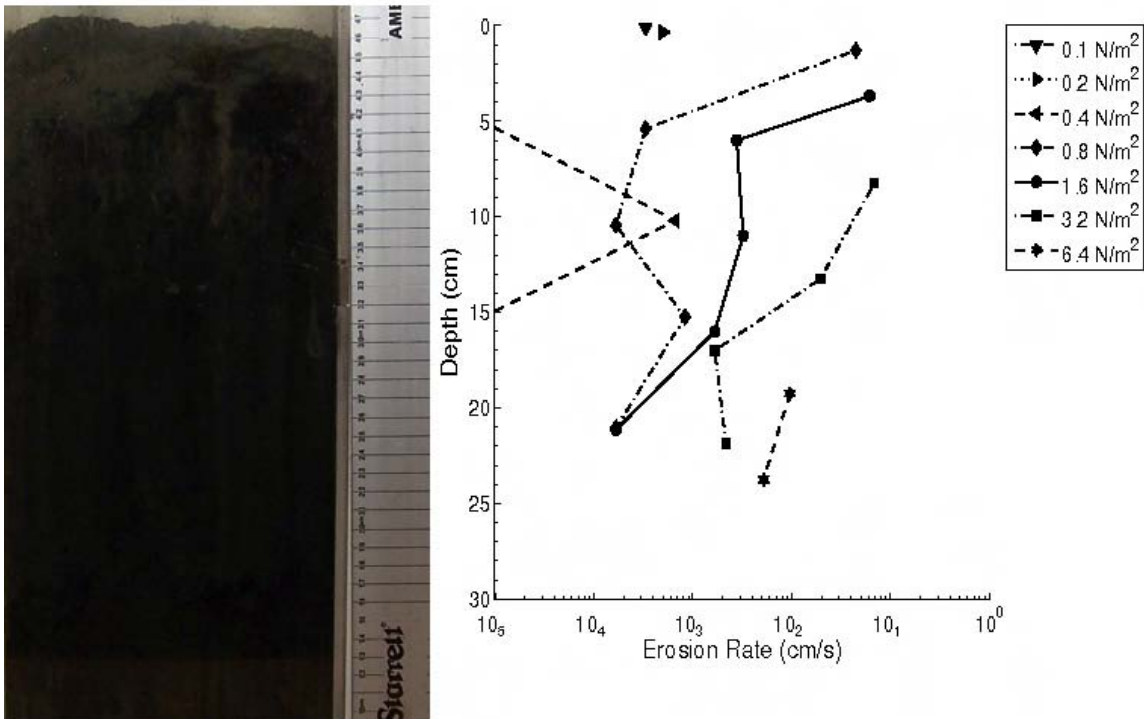
Figure A.3. Sedflume core image (core SFSB01) and corresponding erosion rates vs. depth of core for several shear stresses.

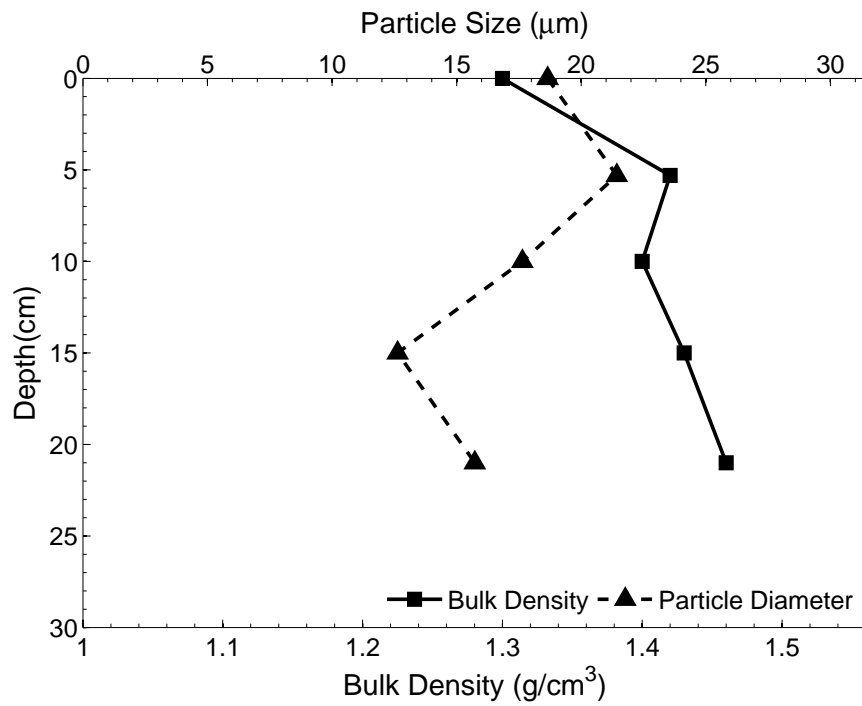
Figure A.4. Bulk densities and median particle sizes vs. core depth for core SFSB01.

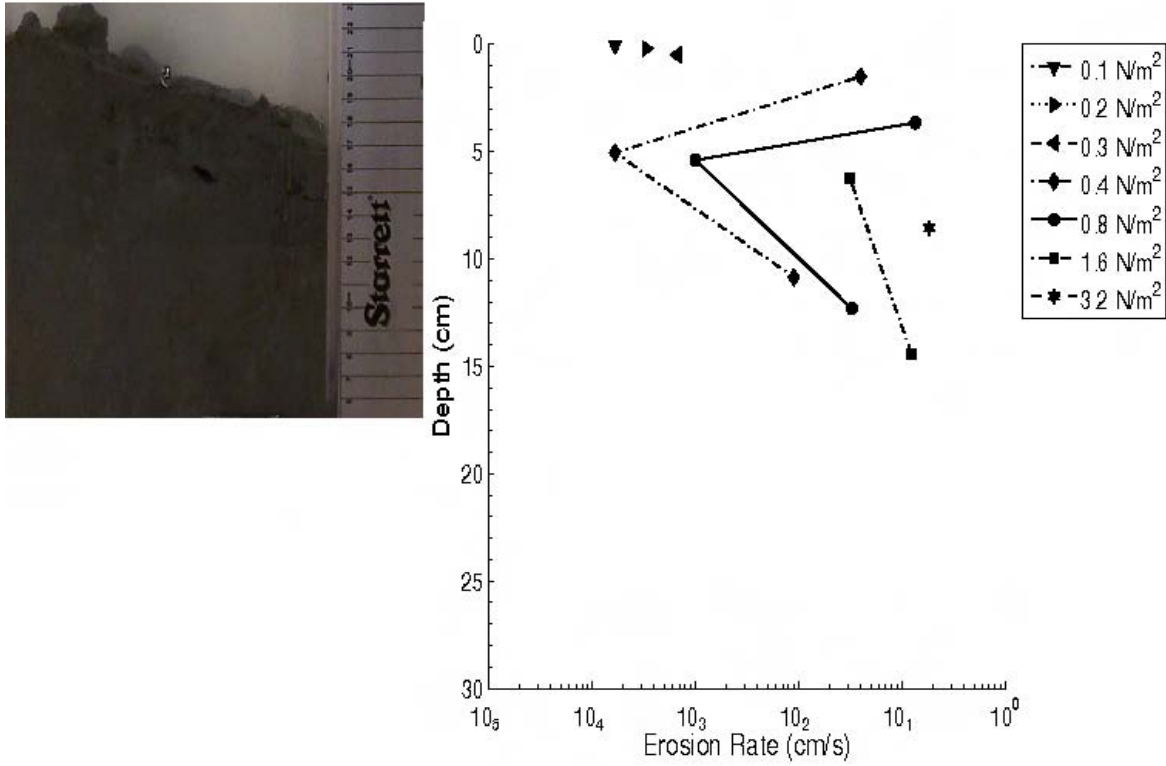
Figure A.5. Sedflume core image (core SFSB02) and corresponding erosion rates vs. depth of core for several shear stresses.

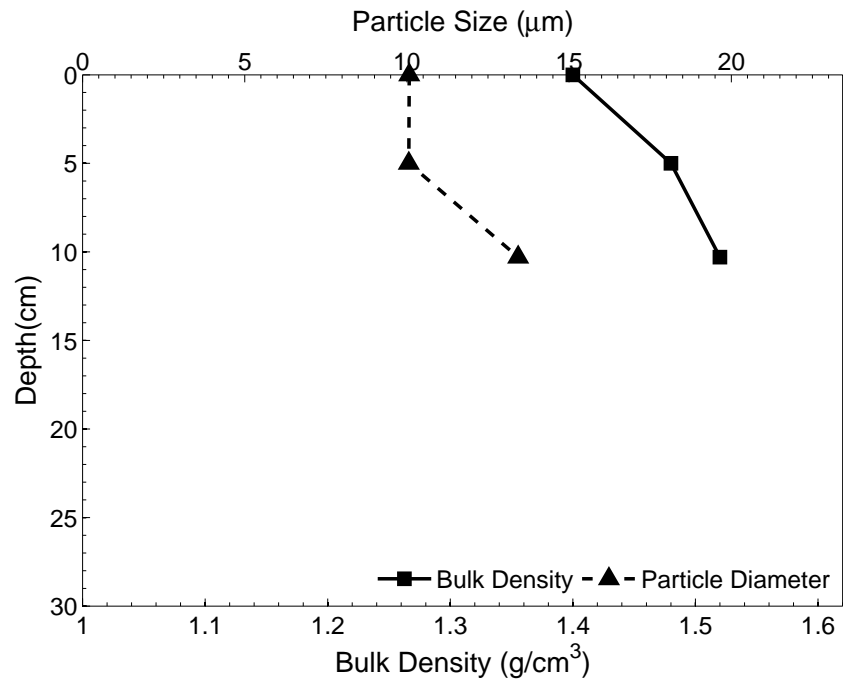
Figure A.6. Bulk densities and median particle sizes vs. core depth for core SFSB02.

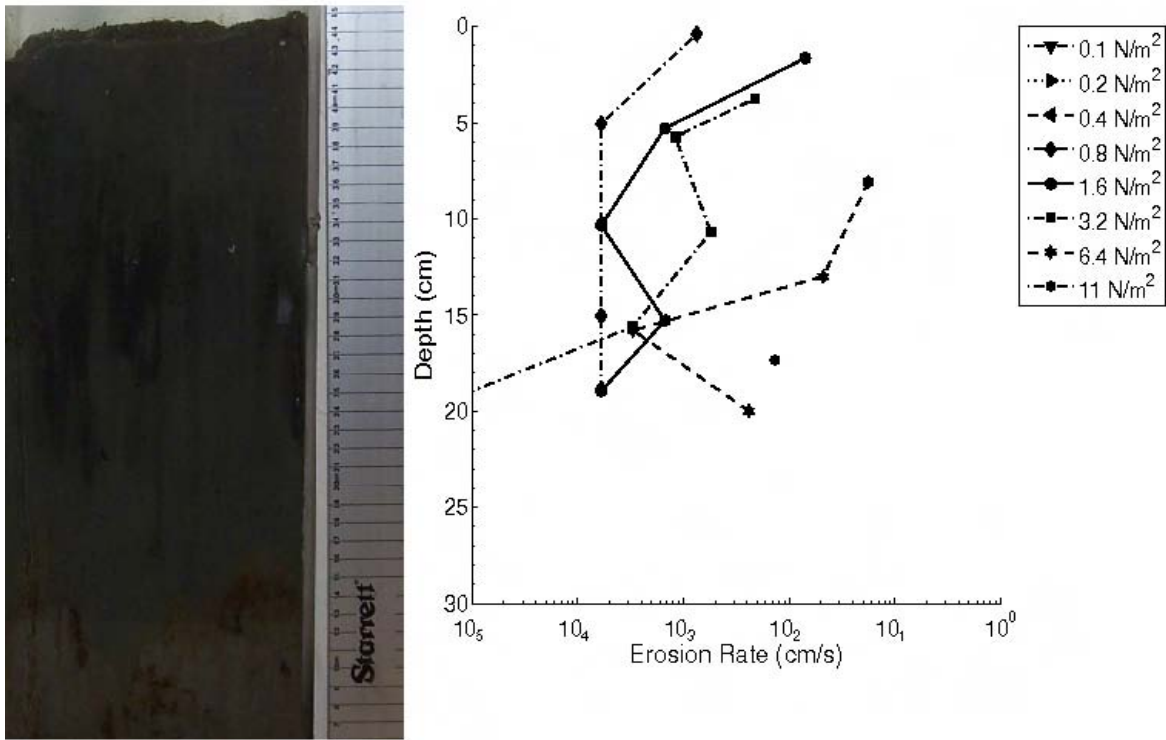
Figure A.7. Sedflume core image (core SFKP01) and corresponding erosion rates vs. depth of core for several shear stresses.

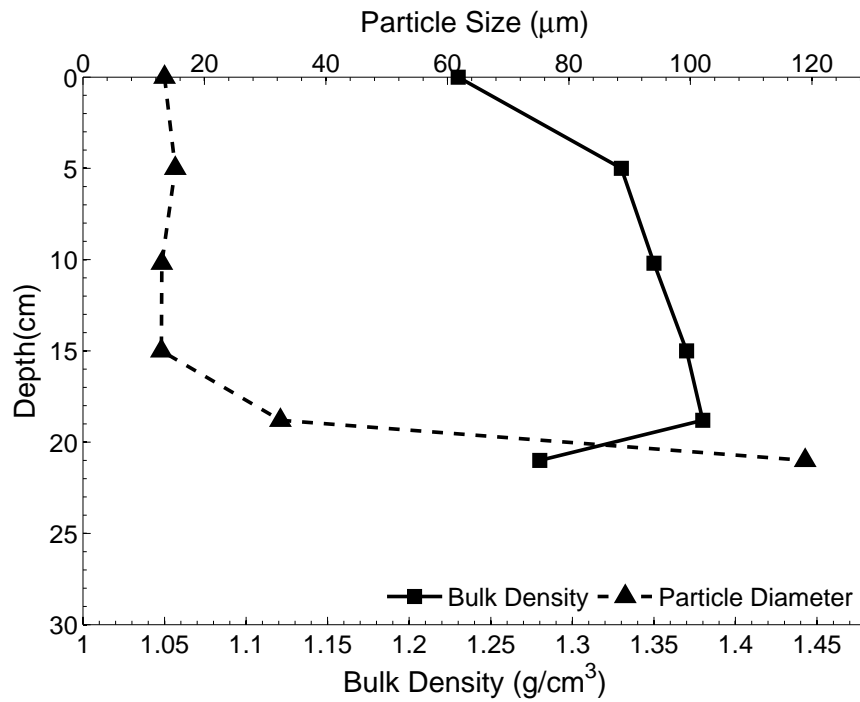
Figure A.8. Bulk densities and median particle sizes vs. core depth for core SFKP01.

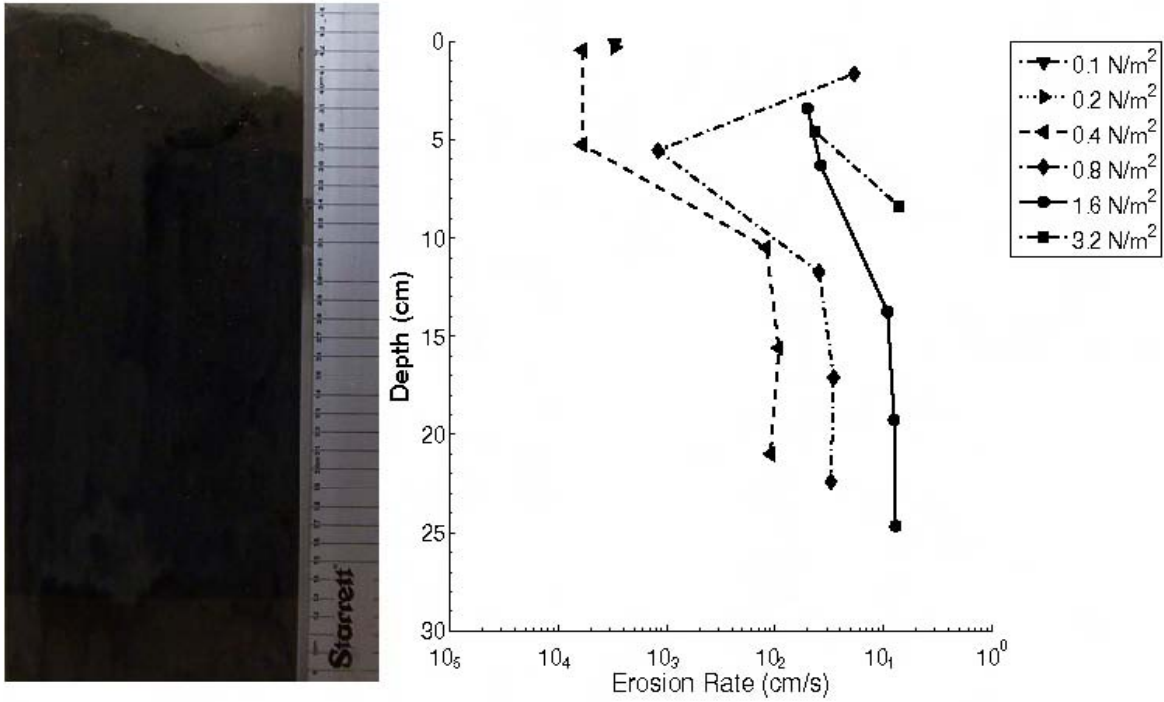
Figure A.9. Sedflume core image (core SFKP02) and corresponding erosion rates vs. depth of core for several shear stresses.

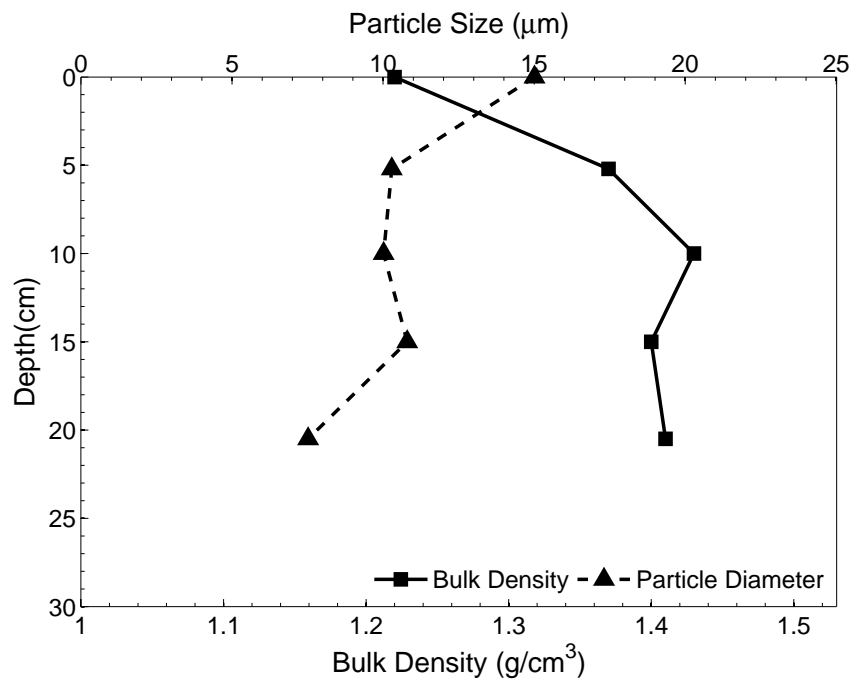
Figure A.10. Bulk densities and median particle sizes vs. core depth for core SFKP02.

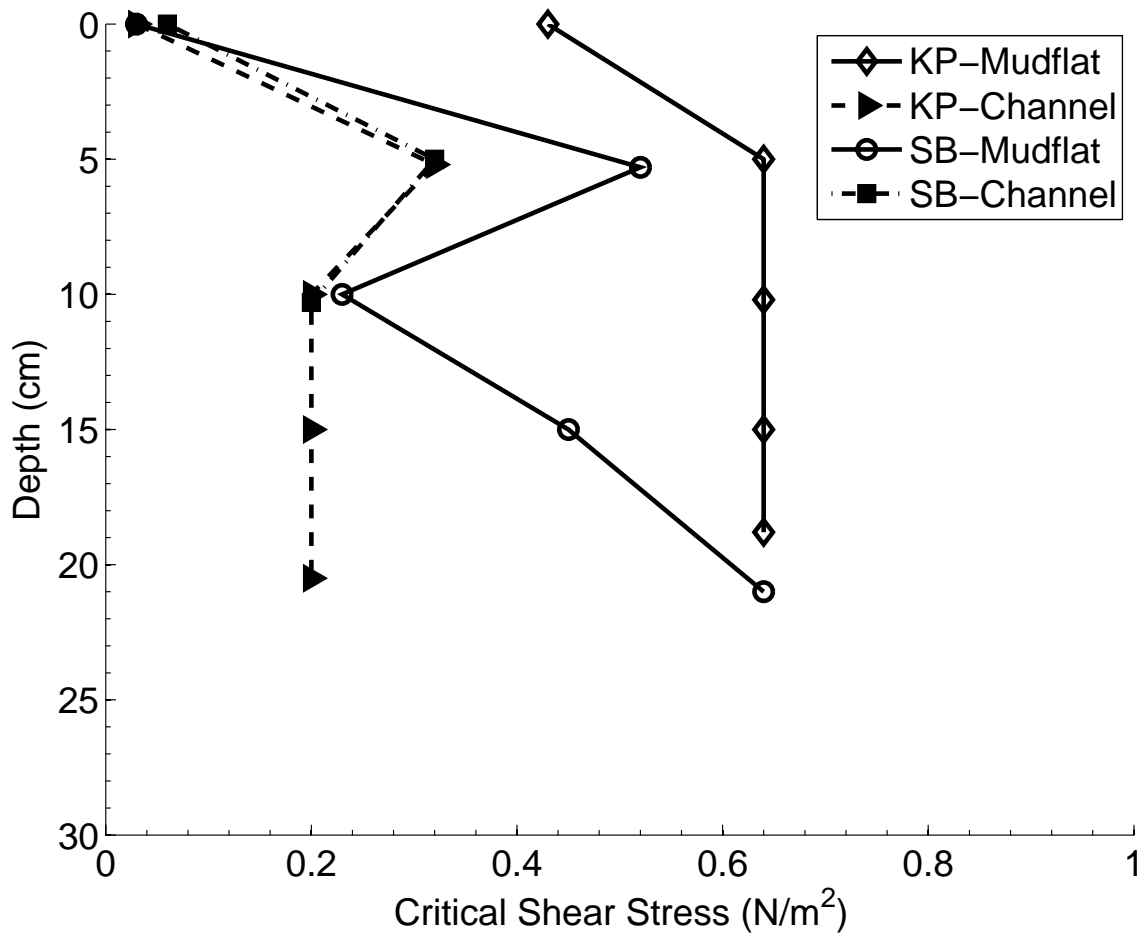
Figure A.11. Critical shear stress values vs. depth (as computed by a Sedflume analysis) for the four SEI cores sampled from Elkhorn Slough. KP – Kirby Park; SB – Seal Bend.
